Manhole Inspection Summary

Manhole # S25II_024MH

Location Address: **402 GOLD ST**

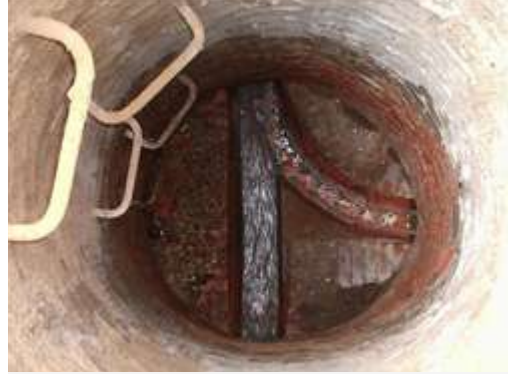
Top View

Corroded steps. Bench debris.

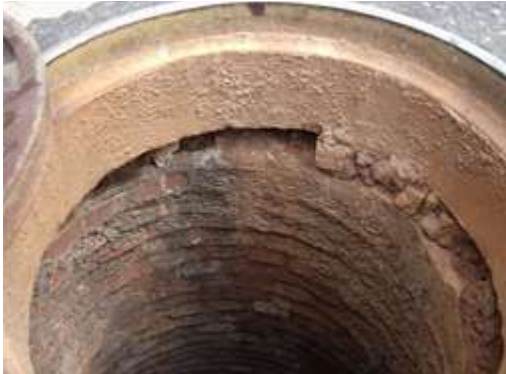
Defect

Frame leaks. Adjustment deterioration, loose brick and infiltration. Barrel infiltration - other side.

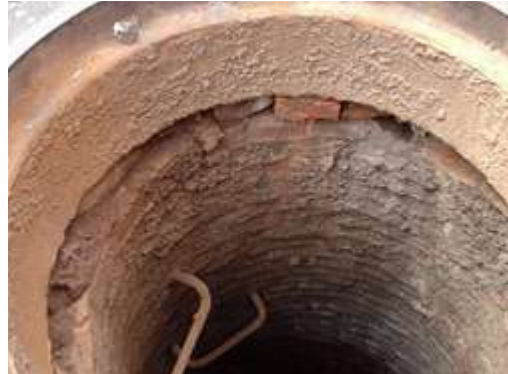
Defect

Frame leaks. Adjustment deterioration, loose brick and infiltration. Barrel infiltration.

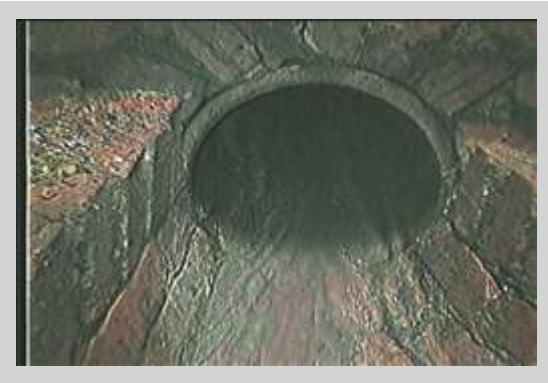
10 in. Circular Gravity Sewer Pipe Out @ 12 O'Clock

Channel deterioration.

Infiltration: **Evidence** Pipe Seal Cond: **Cracked**

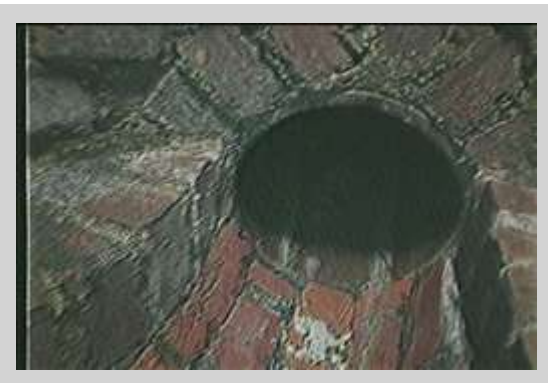
10 in. Circular Gravity Sewer Pipe In @ 3 O'Clock

Infiltration: **Evidence** Pipe Seal Cond: **Unknown**

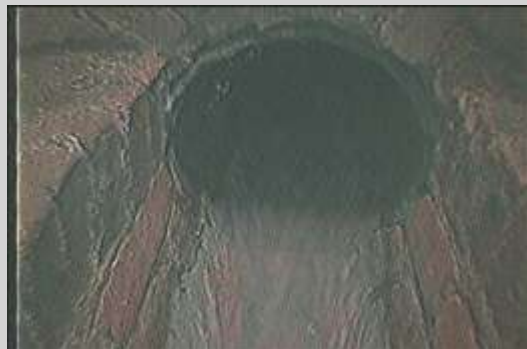
Pipe In @ 6 O'Clock

Infiltration: **Evidence**
